## TECH TIPS

### CLUTCH/TRANSMISSION INSTALLATION TIPS

#### 1986 and newer V8 Mustangs

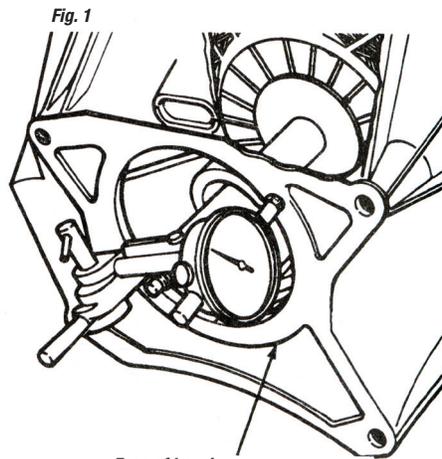
Fig. 1

Face of housing  
(must be clean and free of nicks,  
burrs or foreign material).

The first step is to check bellhousing face runout. You are checking for parallelism of the back of the bellhousing to the back of the block. Install the dial indicator (as shown in Fig. 1). Rotate the crankshaft and mark down the reading. Be sure to push the crankshaft against the thrust bearing for an accurate reading. Maximum runout is .010. The next step is checking bellhousing bore runout. You are checking to see if the bellhousing bore centerline is aligned with crankshaft centerline. Reposition the dial indicator in the bellhousing bore (as shown in Fig. 2). Rotate the crankshaft and mark down the readings. Maximum out of concentricity is .015. If the bore runout is out of spec, install appropriate offset dowels.

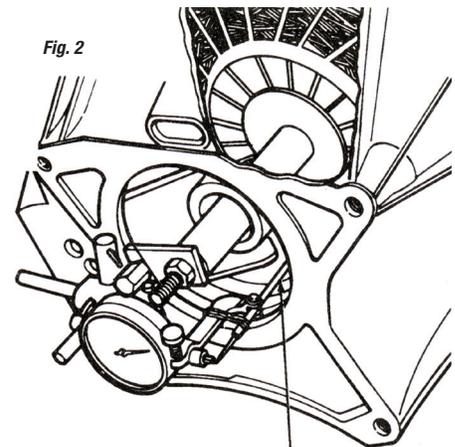
Fig. 2

Level tip rides on bore surface.  
This surface must be clean  
and free of nicks, burrs  
or foreign material.
